A Red Light Running (RLR) Photo Enforcement System was installed at the intersection of US Rte. 12/45 (Mannheim) at IL Rte. 19 (Irving Park) on May 11, 2009, after finding limited success with other attempted measures to promote safer driving and improve compliance with traffic laws. The following statistical analysis was performed through 2015. Calendar year 2016 was not included as the Illinois Department of Transportation (IDOT) has not yet completed collecting all data. The statistical analysis will be updated annually, as collected data becomes available from IDOT.

**US Rte. 12/45 (Mannheim) at IL Rte. 9 (Irving Park)**  
**Schiller Park, IL**

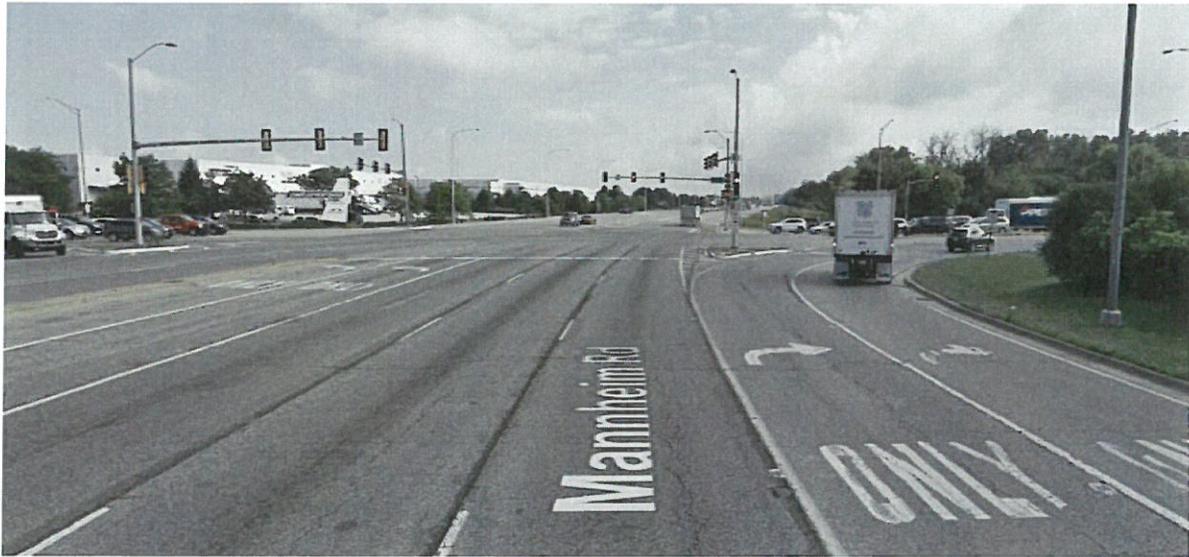
**US Rte. 12/45 (Mannheim) at IL Rte. 19 (Irving Park), Northbound Approach**

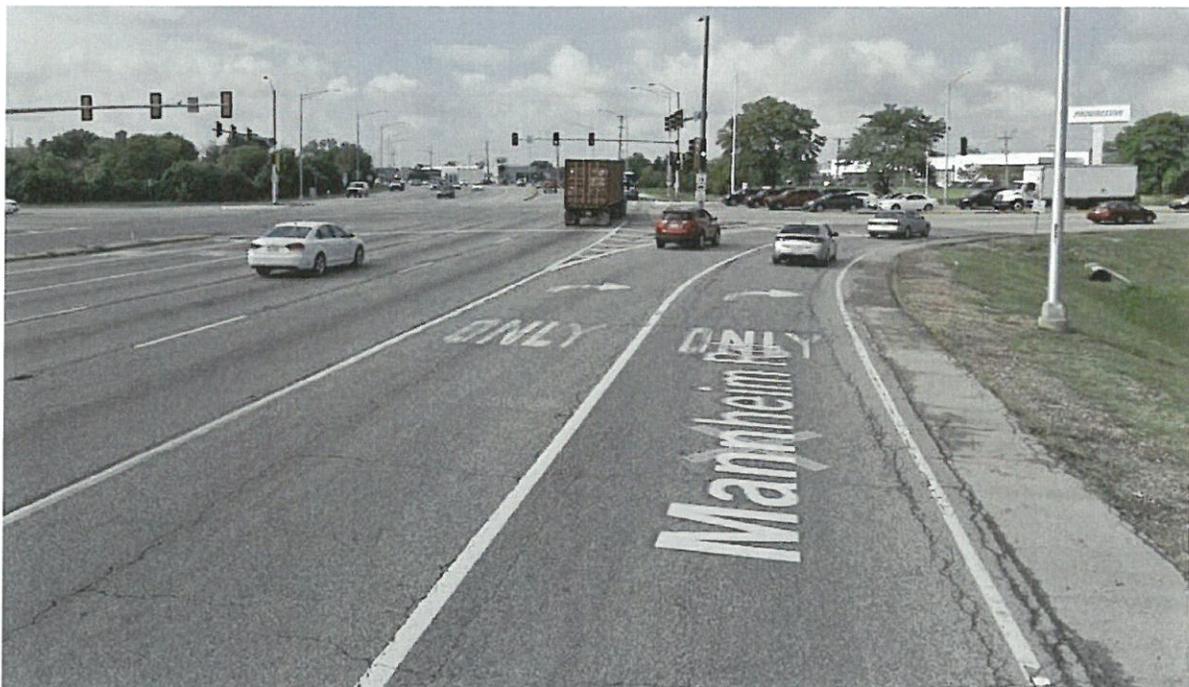
**US Rte. 12/45 (Mannheim) at IL Rte. 19 (Irving Park), Southbound Approach**

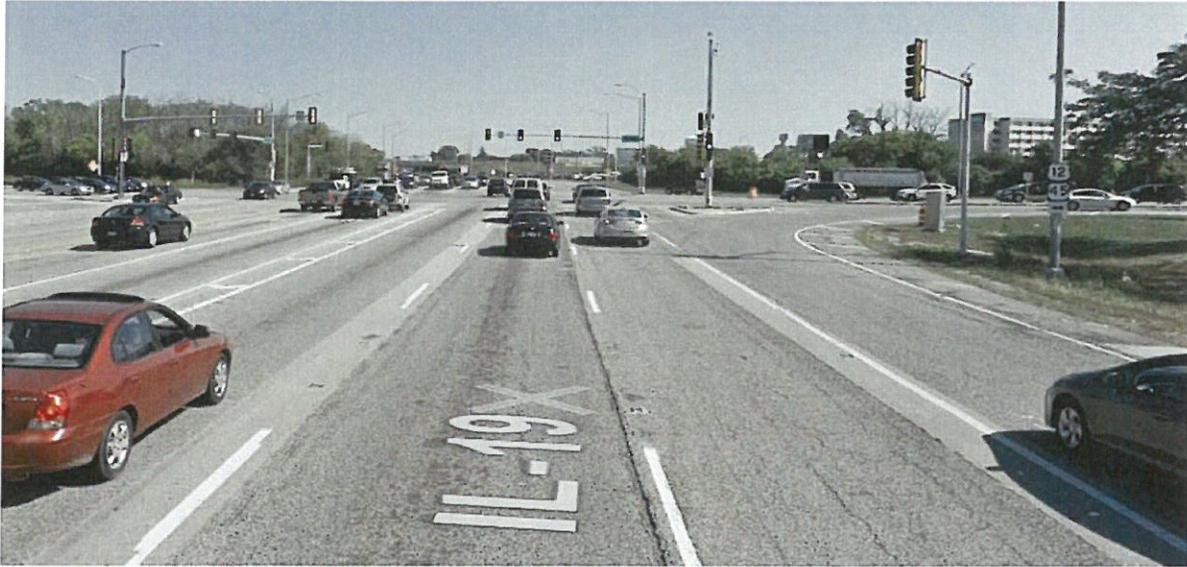
**US Rte. 12/45 (Mannheim) at IL Rte. 19 (Irving Park), Eastbound Approach**

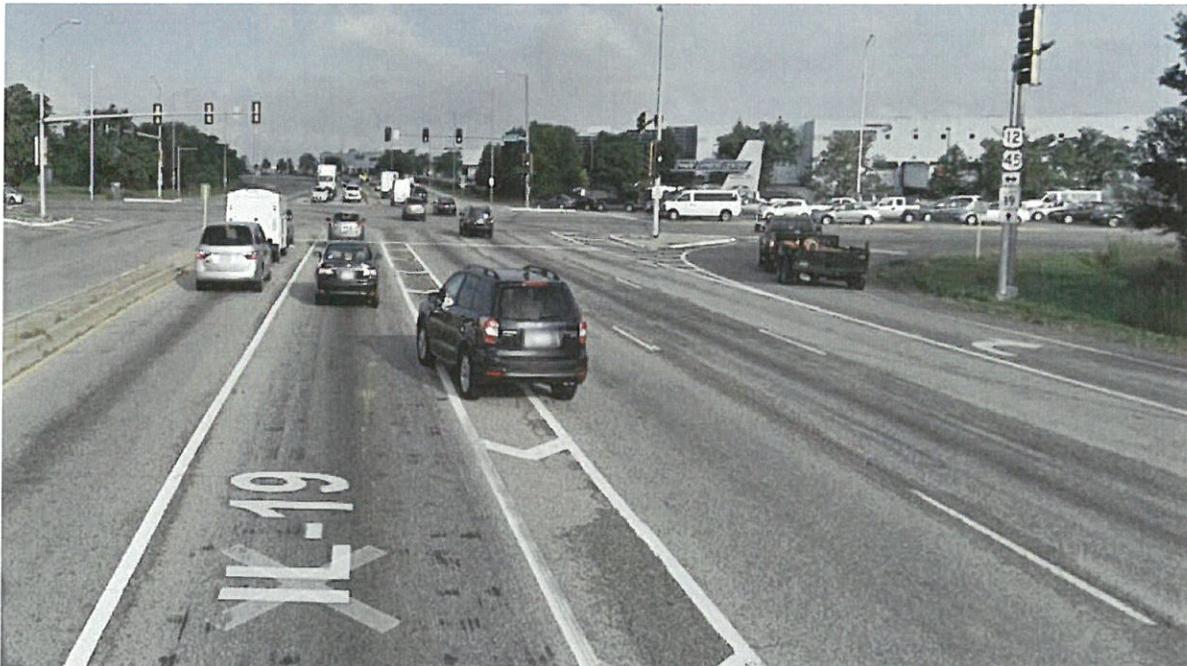
**US Rte. 12/45 (Mannheim) at IL Rte. 19 (Irving Park), Westbound Approach**

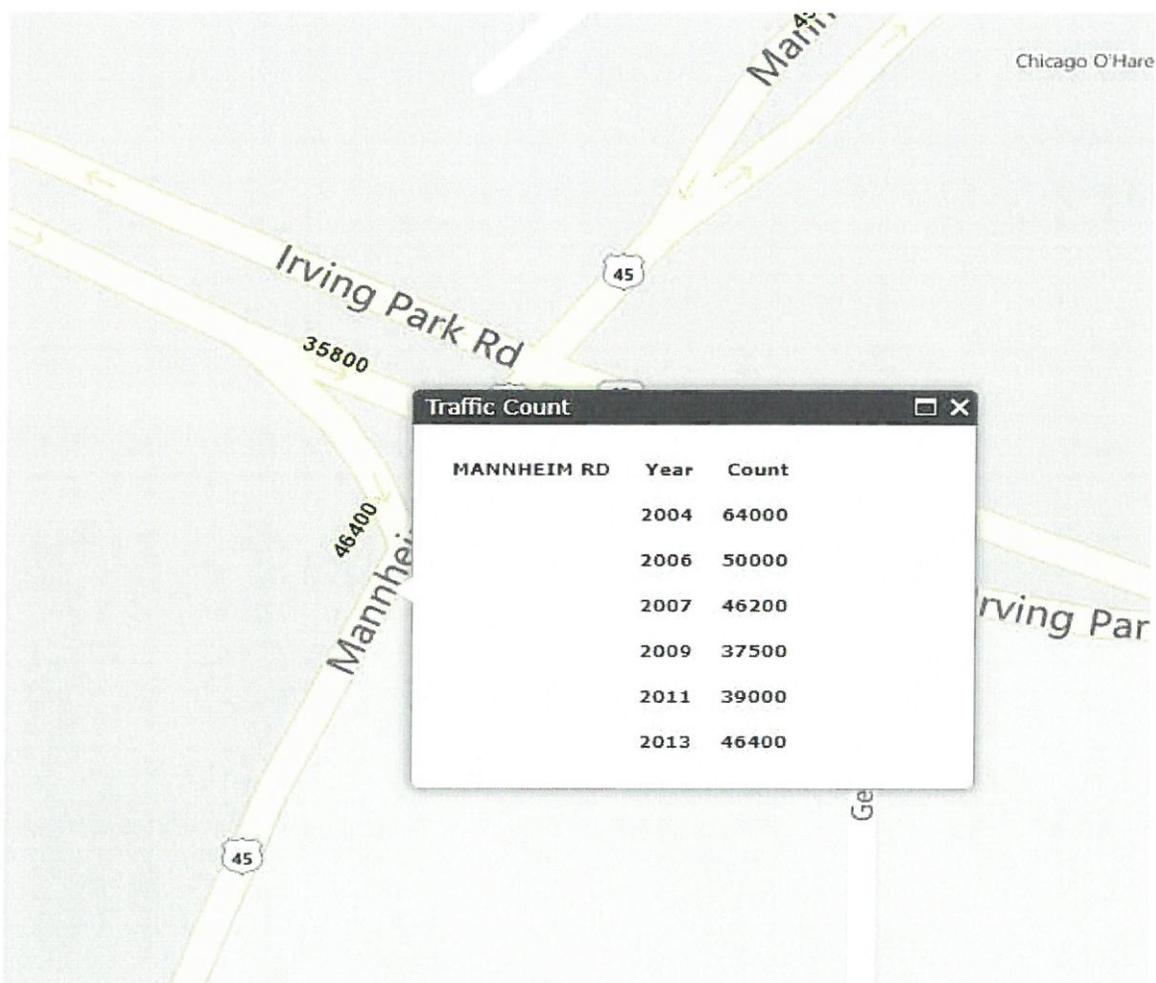
US Rte. 12/45 (Mannheim) at IL Rte. 19 (Irving Park) (Northbound)

- 64,000 (2004)
- 50,000 (2006)
- 46,200 (2007)
- 37,500 (2009)
- 39,000 (2011)
- 46,400 (2013)

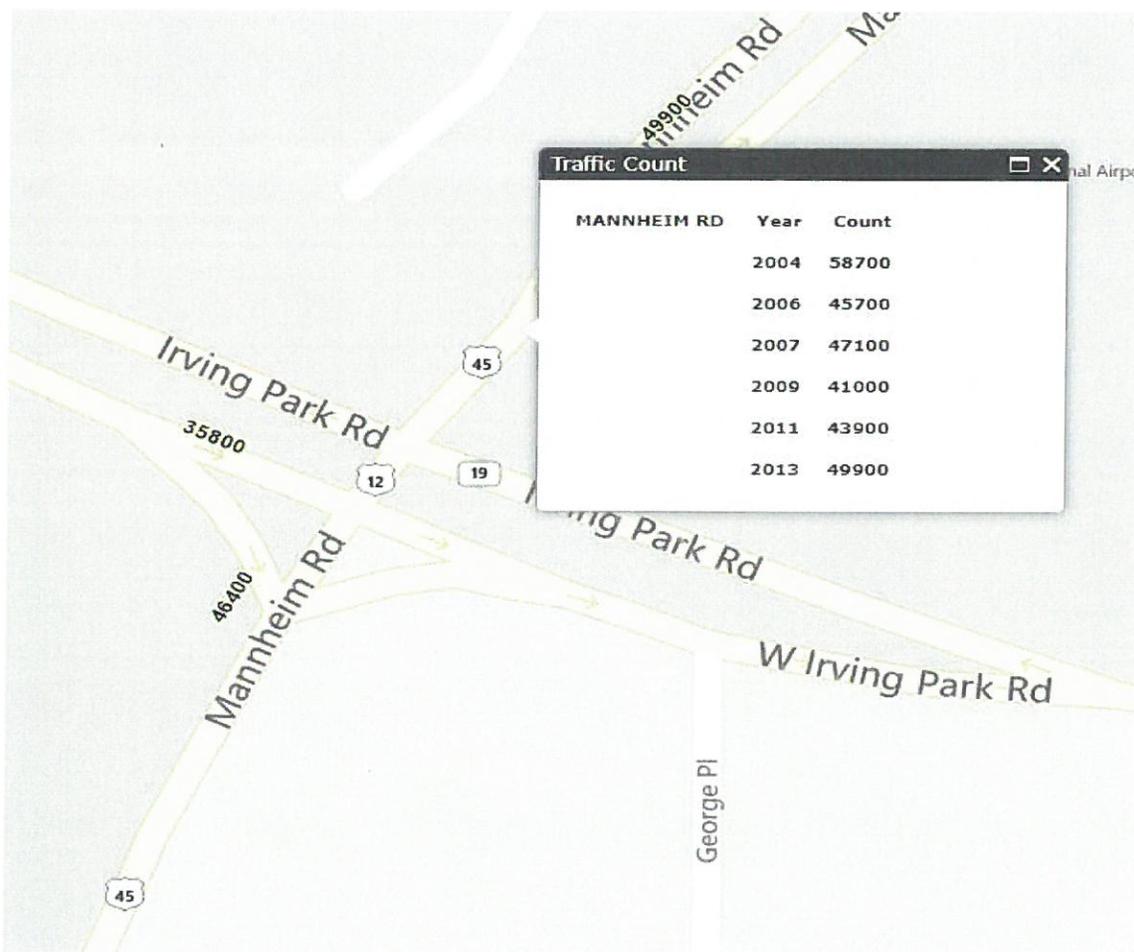
US Rte. 12/45 (Mannheim) at IL Rte. 19 (Irving Park) (Southbound)

- 58,700 (2004)
- 45,700 (2006)
- 47,100 (2007)
- 41,000 (2009)
- 43,900 (2011)
- 49,900 (2013)

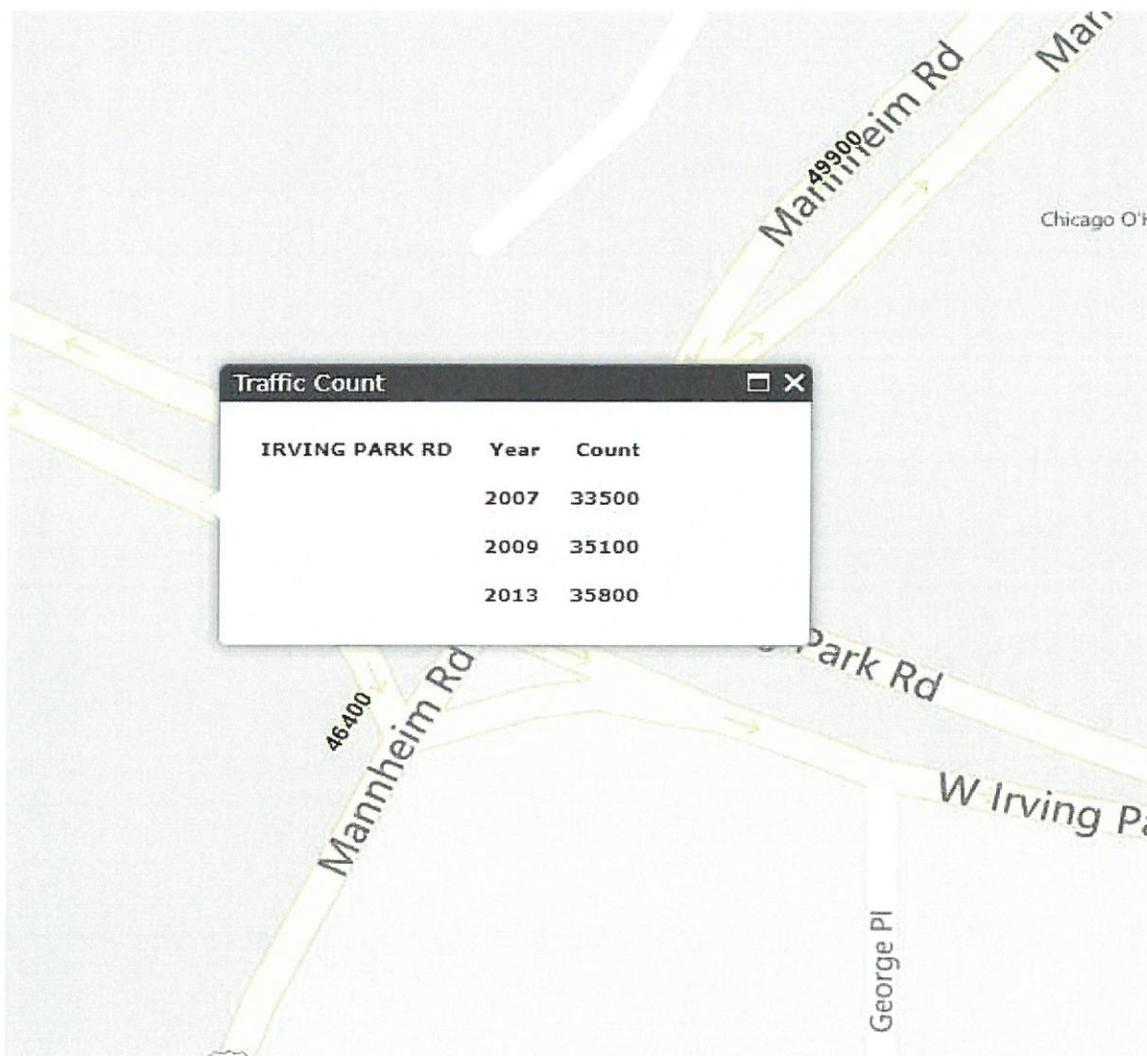
US Rte. 12/45 (Mannheim) at IL Rte. 19 (Irving Park) (Eastbound)

- 33,500 (2007)
- 35,100 (2009)
- 35,800 (2013)

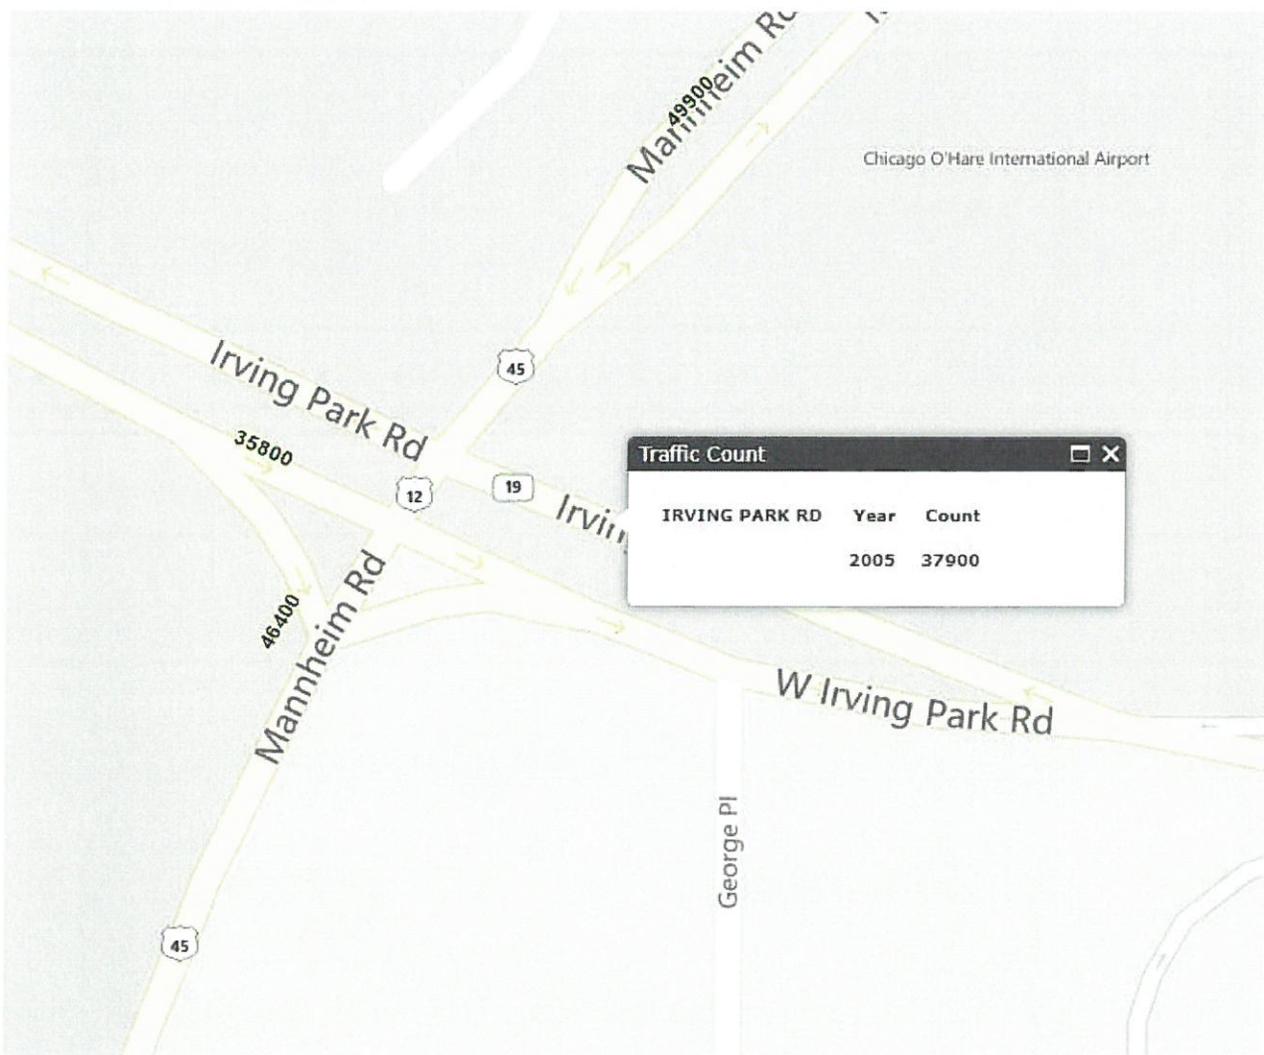
US Rte. 12/45 (Mannheim) at IL Rte. 19 (Irving Park)\_(Westbound)

- 37,900 (2005)
