A Red Light Running (RLR) Photo Enforcement System was installed at the intersection of IL Rte. 19 (Irving Park) at Des Plaines River Road on May 1, 2008, after finding limited success with other attempted measures to promote safer driving and improve compliance with traffic laws. The following statistical analysis was performed through 2015. Calendar year 2016 was not included as the Illinois Department of Transportation (IDOT) has not yet completed collecting all data. The statistical analysis will be updated annually, as collected data becomes available from IDOT.

IL Rte. 19 (Irving Park) at Des Plaines River Road
Schiller Park, IL

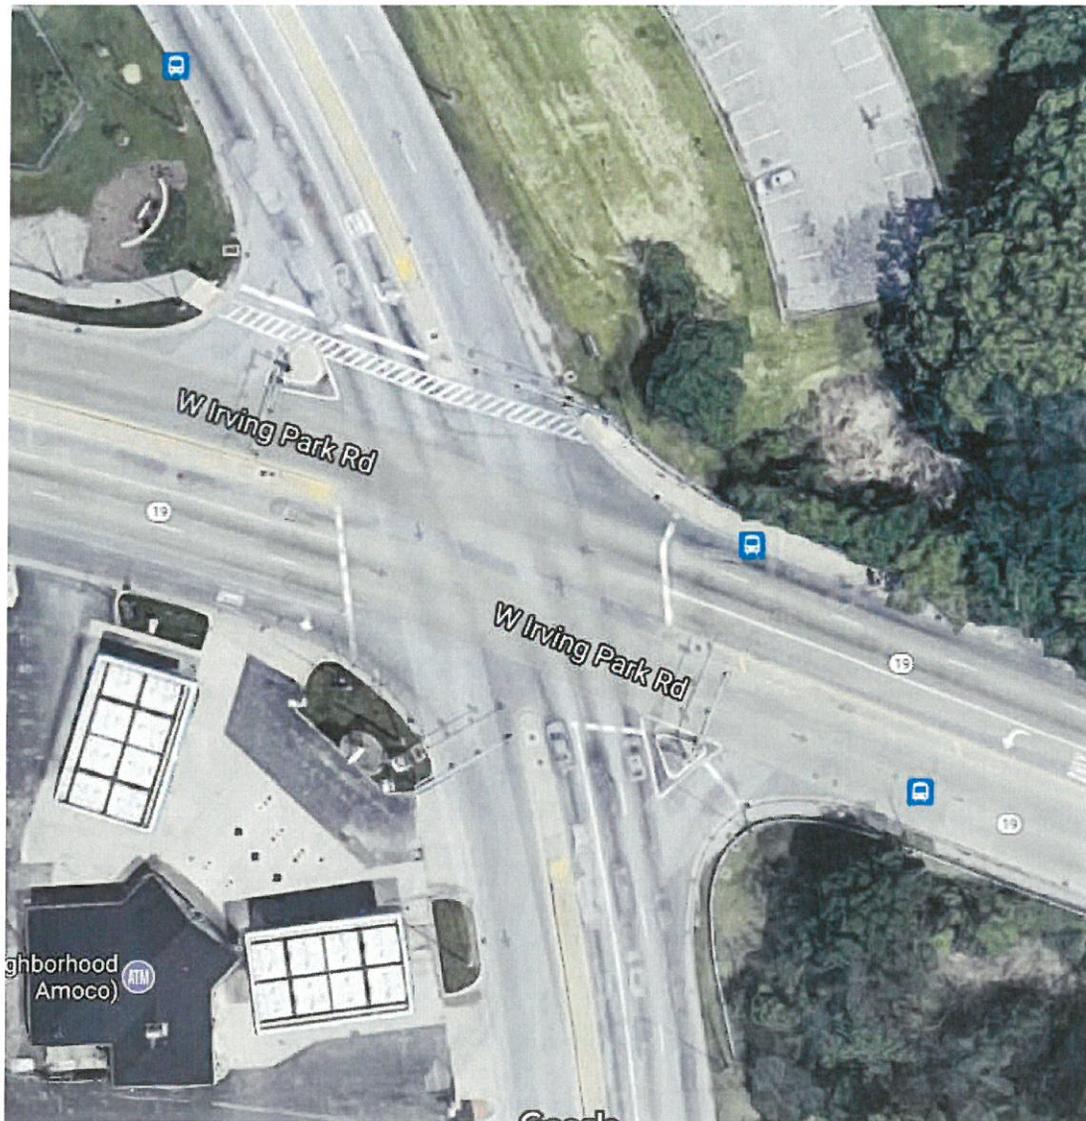
- RLR Photo Enforcement System monitors violations occurring on the eastbound approach of the intersection
- RLR Photo Enforcement System installed: May 1, 2008

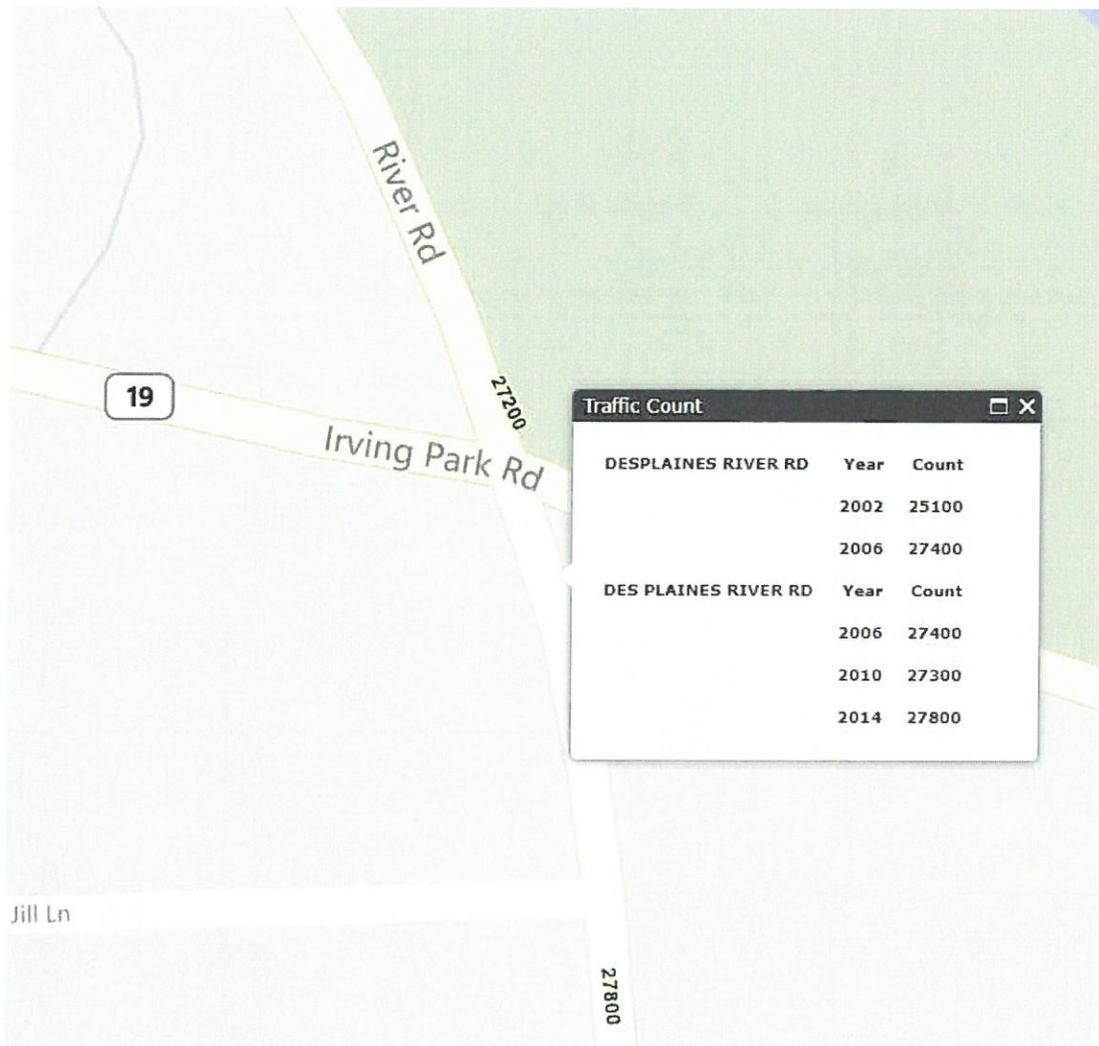
IL Rte. 19 (Irving Park) at Des Plaines River Road (Northbound)

- 25,100 (2002)
- 27,400 (2006)
- 27,300 (2010)
- 27,800 (2014)

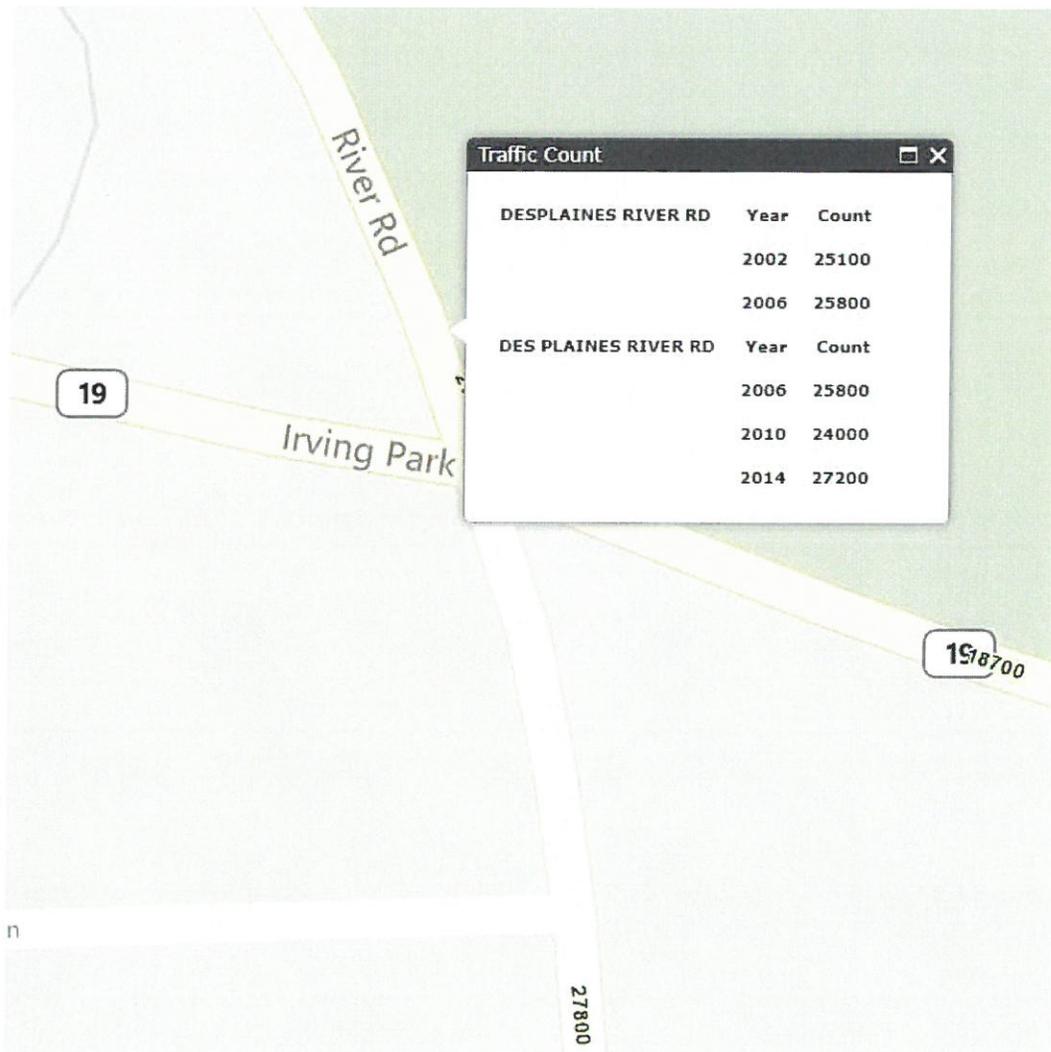
IL Rte. 19 (Irving Park) at Des Plaines River Road (Southbound)

- 25,100 (2002)
- 25,800 (2006)
- 24,000 (2010)
- 27,200 (2014)

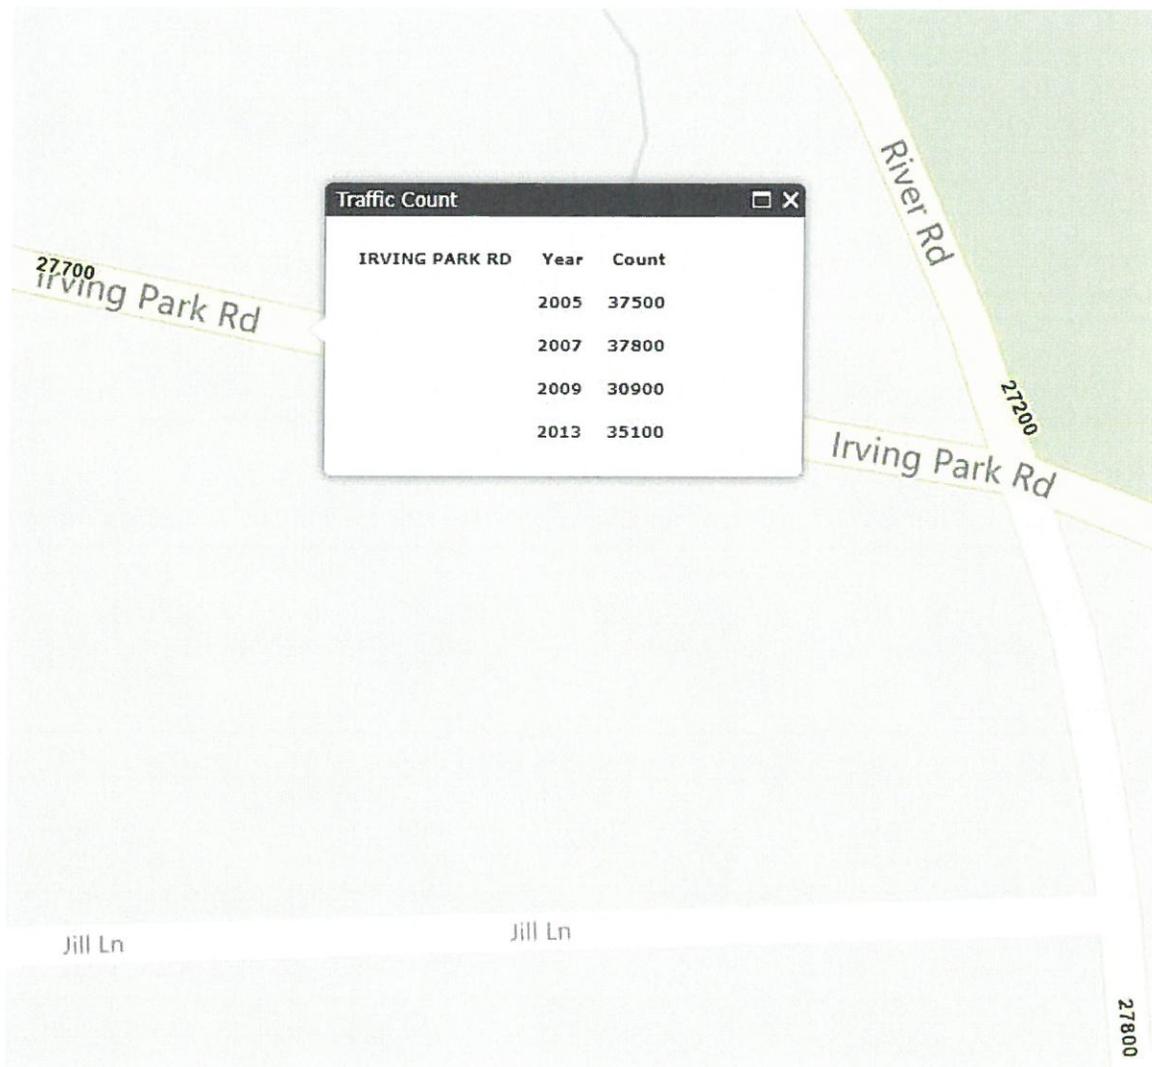
IL Rte. 19 (Irving Park) at Des Plaines River Road (Eastbound)

- 37,500 (2005)
- 37,800 (2007)
- 30,900 (2009)
- 35,100 (2013)

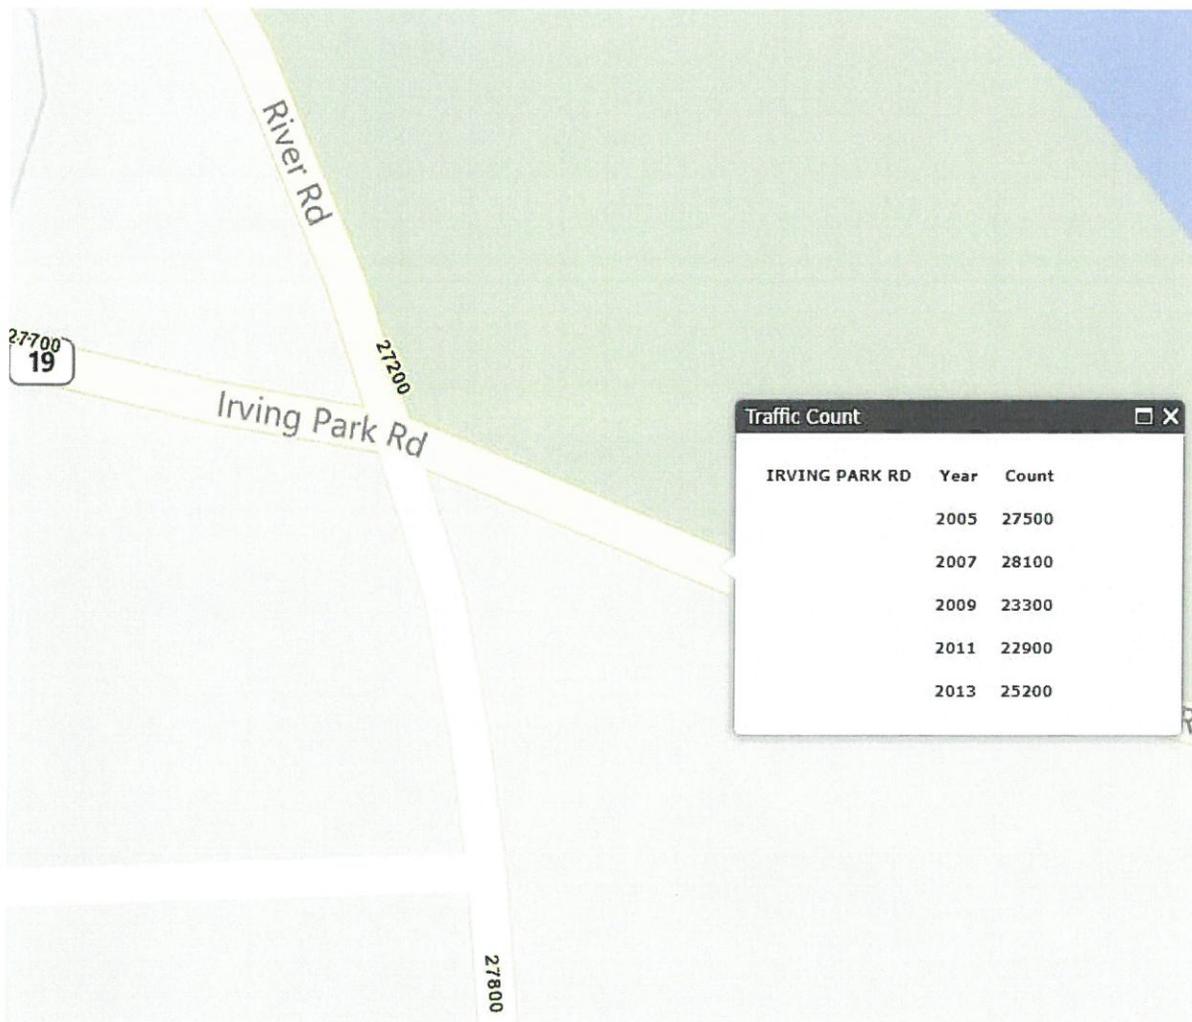
IL Rte. 19 (Irving Park) at Des Plaines River Road (Westbound)

- 27,500 (2005)
- 28,100 (2007)
- 23,300 (2009)
- 22,900 (2011)
- 25,200 (2013)
